June 28, 2019
File No. 262018.063

Subject: Department of Natural Resources Washington Geological Survey,
School Seismic Safety Assessment Project, Contract No. AE 410 -
Seismic Evaluation for **Dayton School District**

School Buildings Evaluated in the Dayton School District

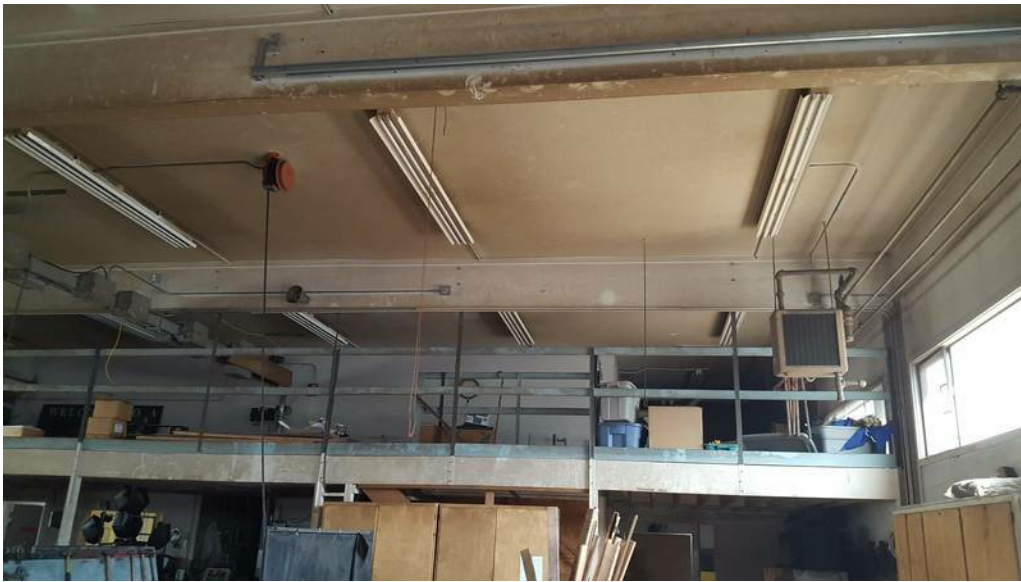
Figure 1-2. Glulam beams at CMU pilasters.

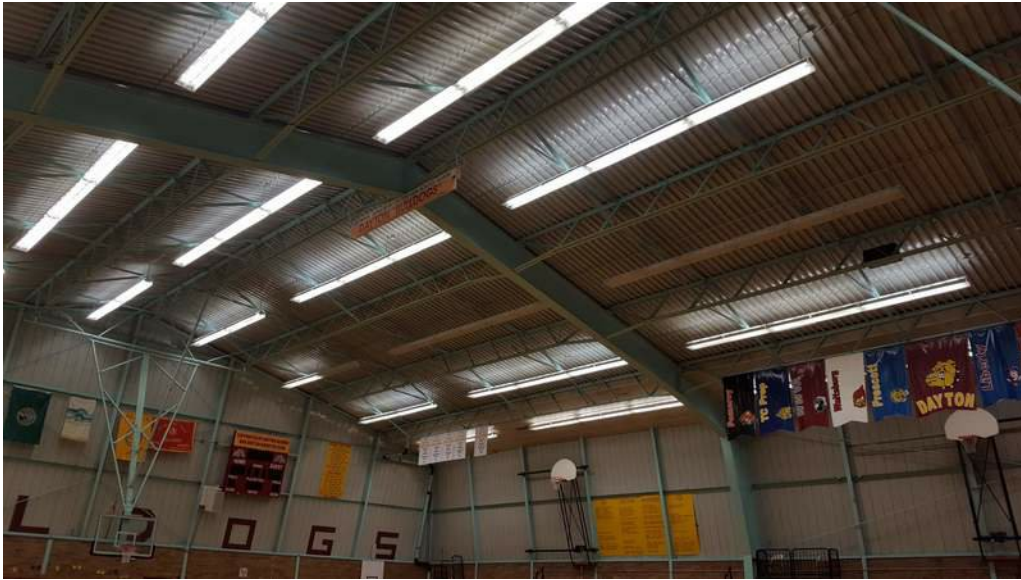
Figure 1-1. Gymnasium, looking east at one of two moment frames.

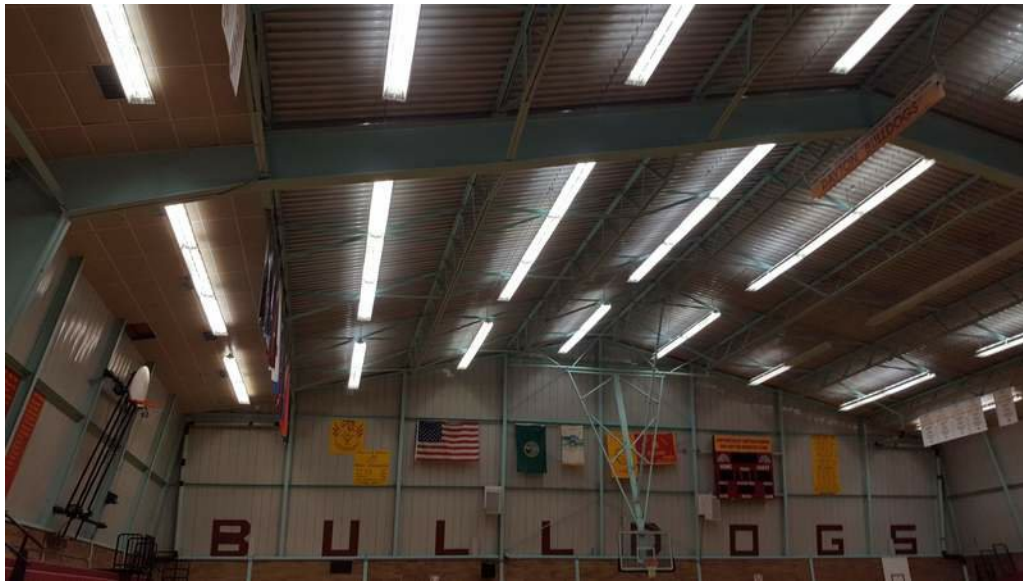
Figure 1-3. Gymnasium, looking northeast.

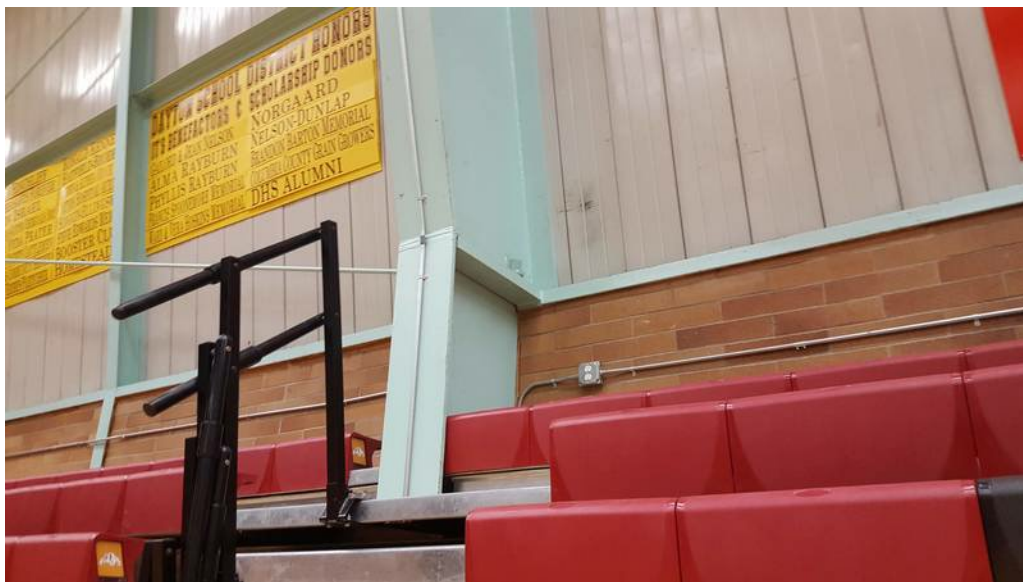
Figure 1-4. Moment frame panel point close-up.

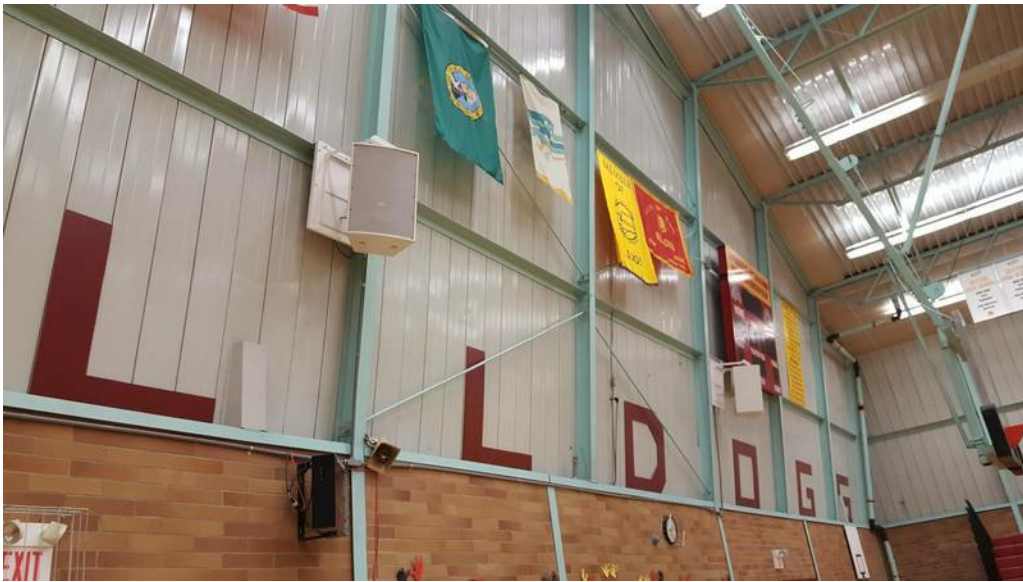
Figure 1-7. Northeast gym wall.

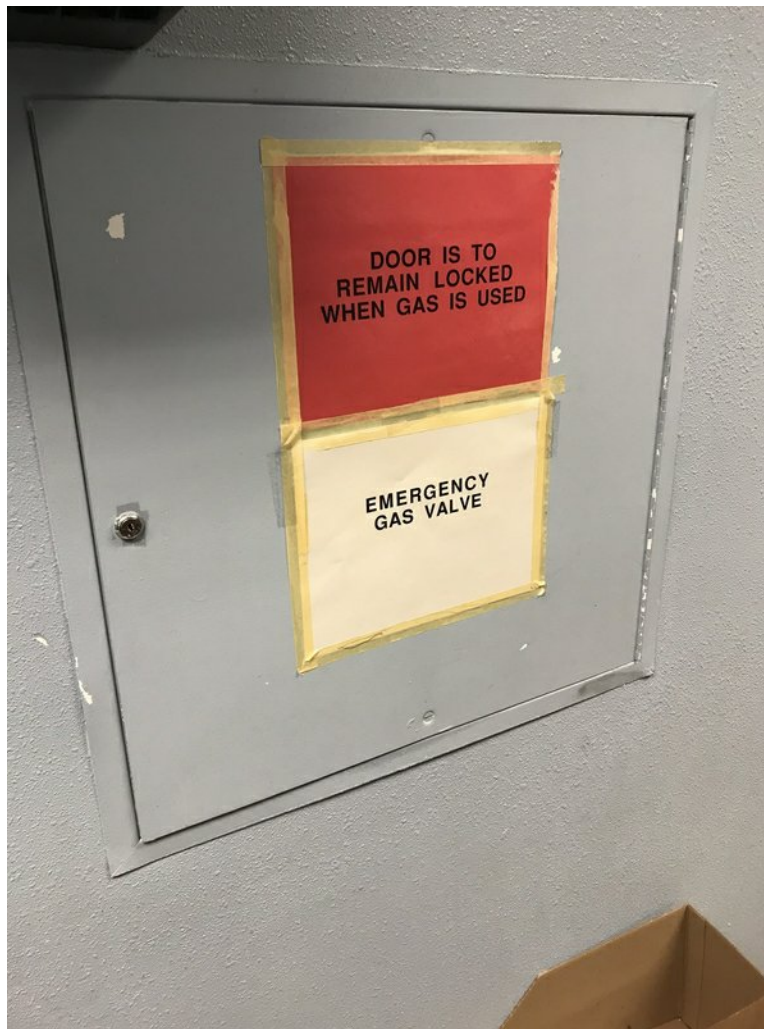
Figure 1-2. Emergency gas shut-off valve.

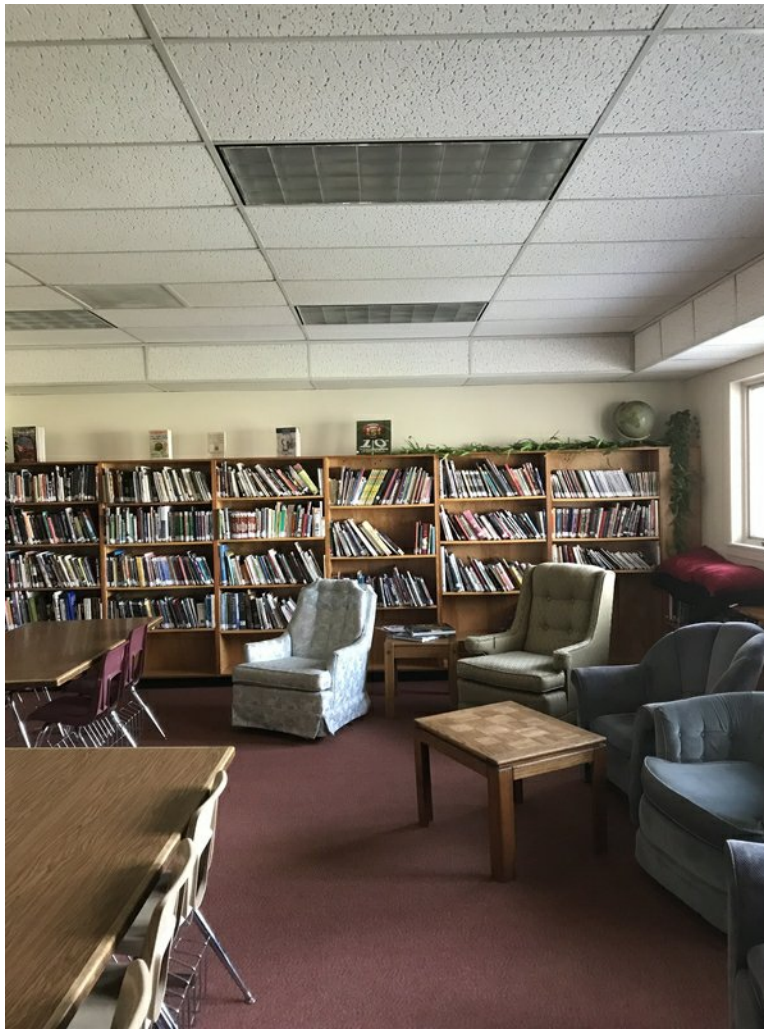
Figure 1-3. Library; bookshelves were positively attached to wall.

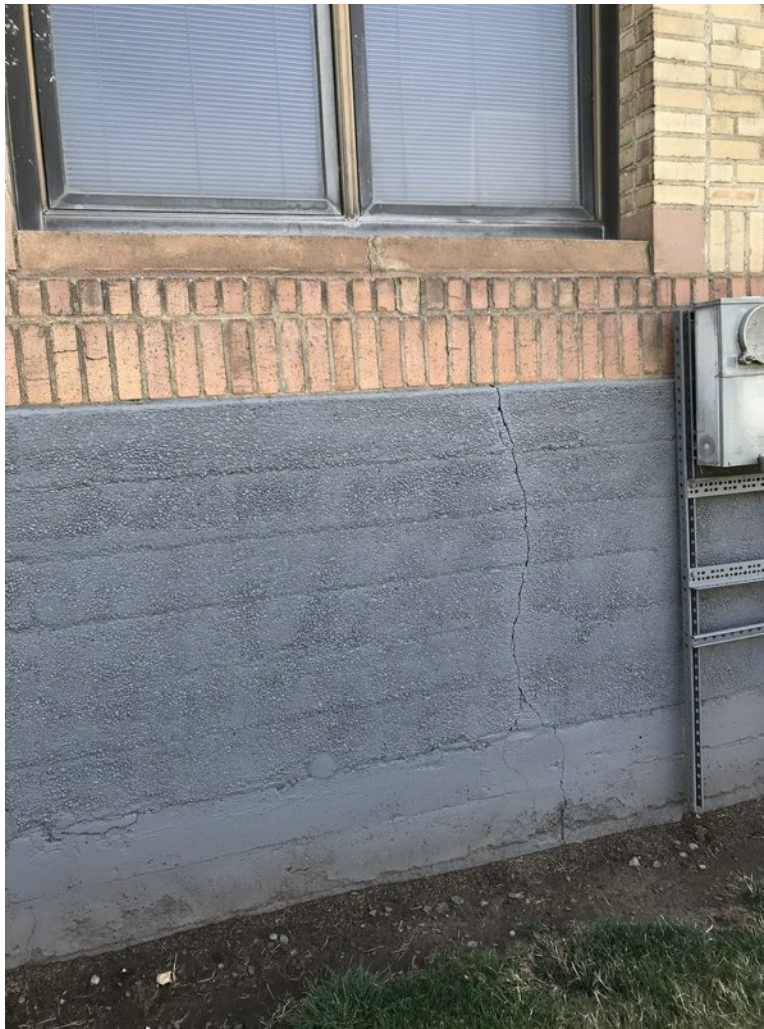
Figure 1-5. Crack at stem wall.

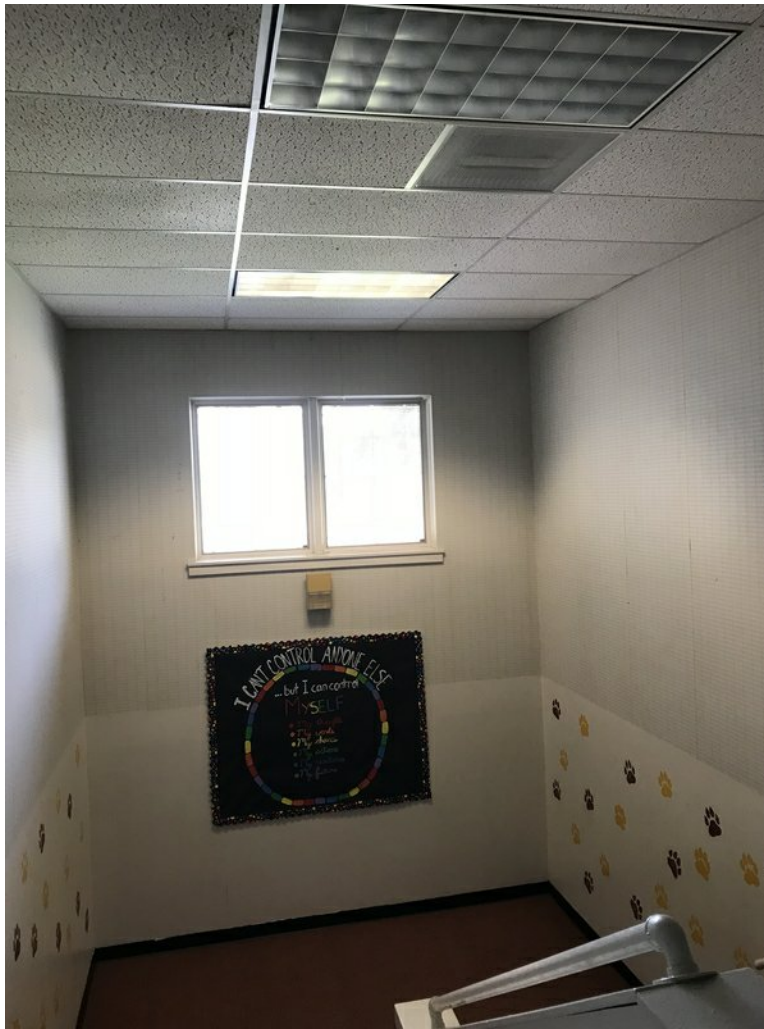
Figure 1-6. Open stairwell.

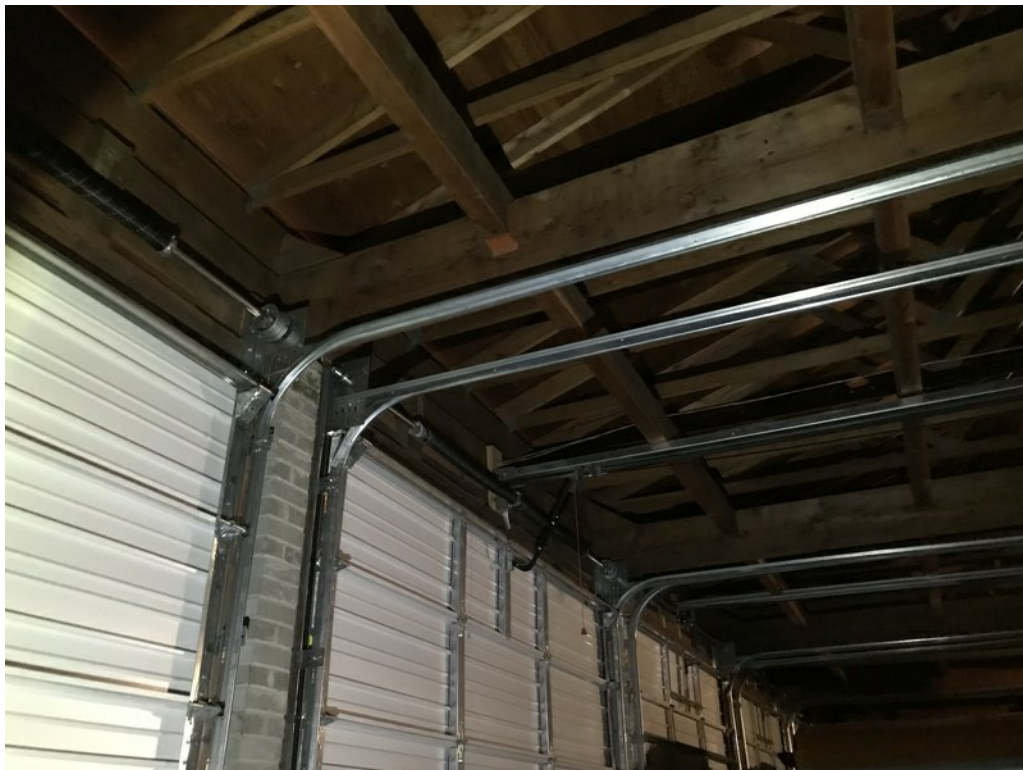
Figure 1-3. Interior view of south wall of building. URM piers supporting joist girders.

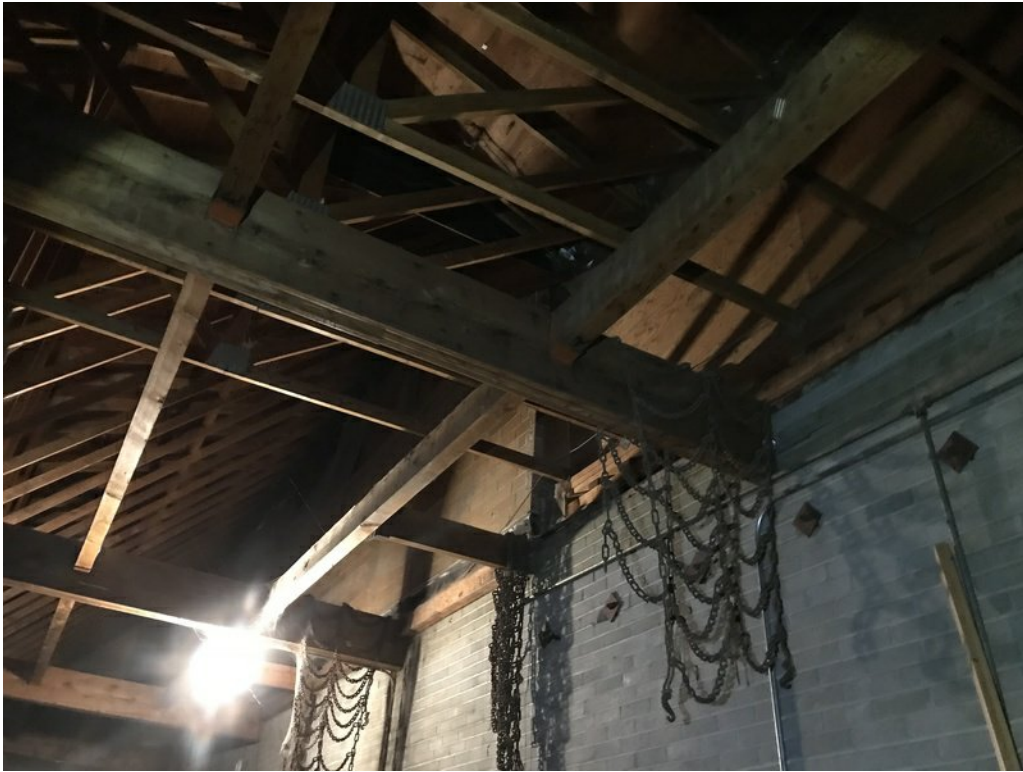
Figure 1-4. Demising wall between bus barn and wood shop.

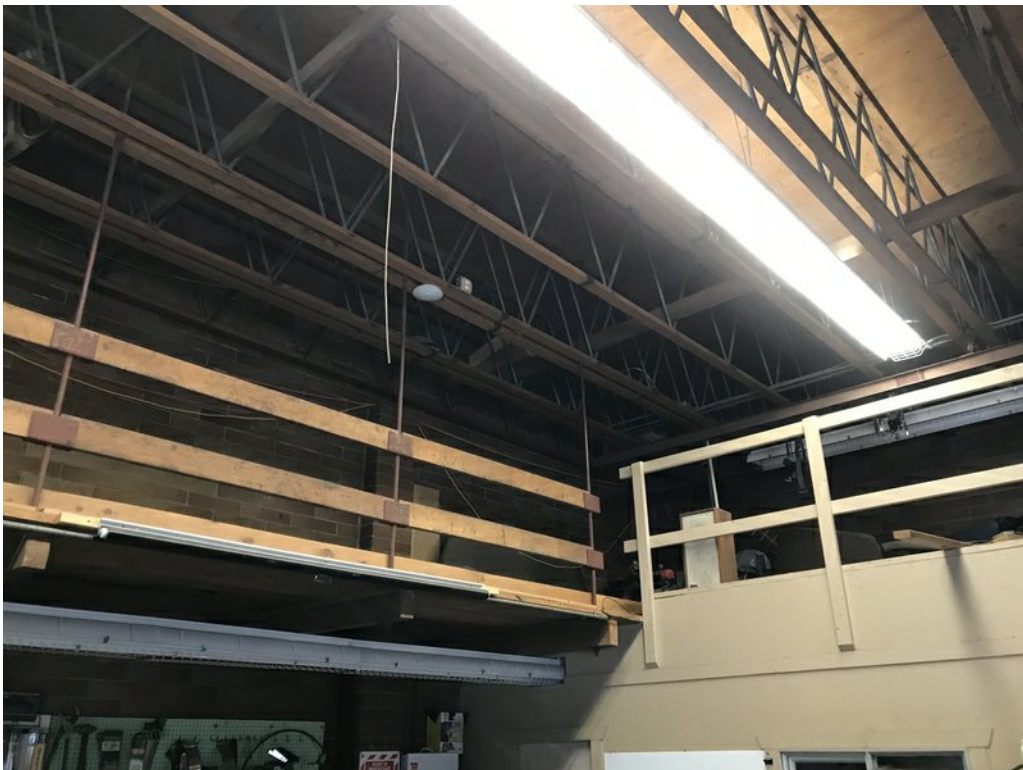
Figure 1-5. Mezzanine in mechanical shop.

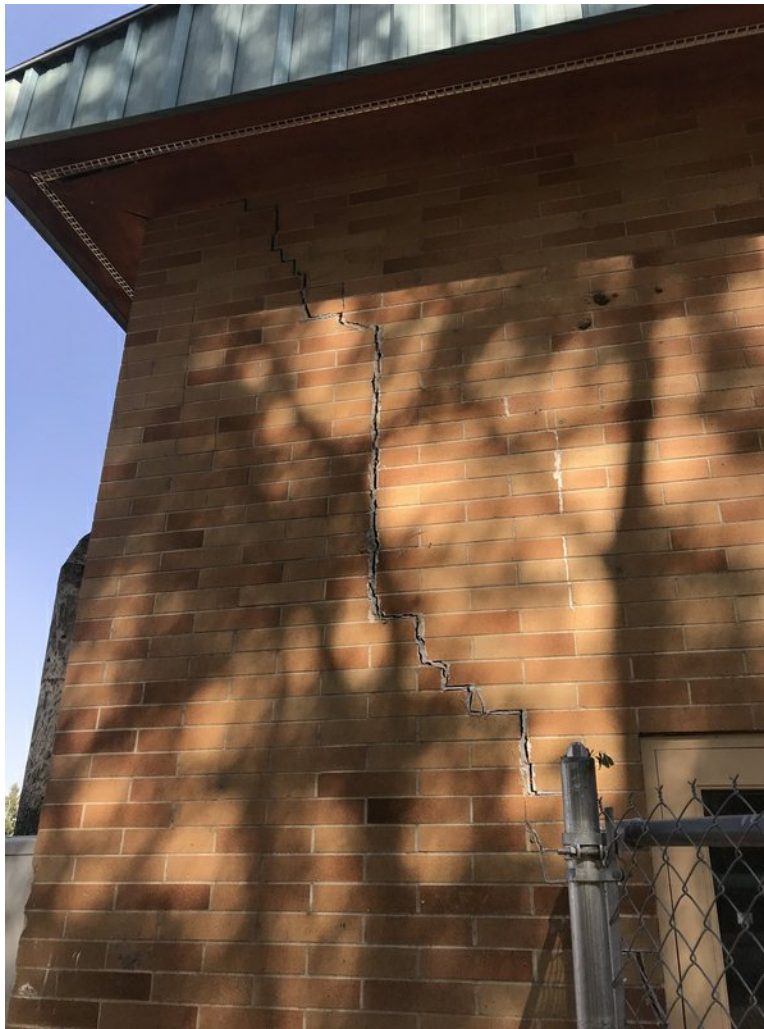
Figure 1-7. Large crack on northwest corner of building

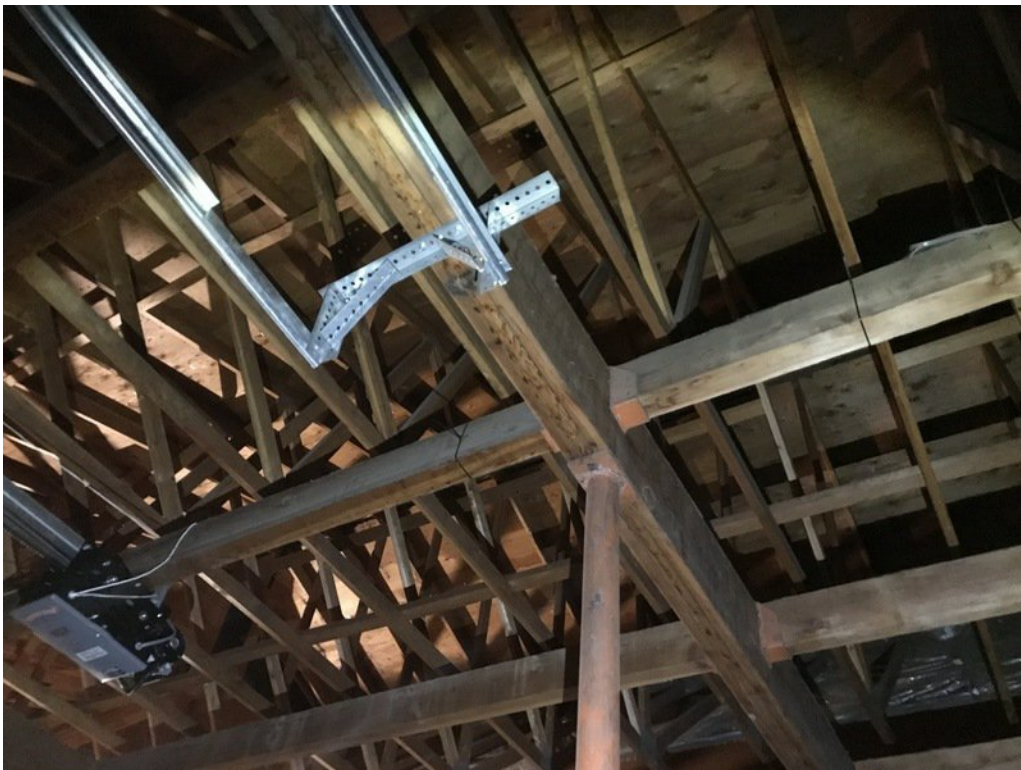
Figure 1-9. Column at mid-span of beam girder.

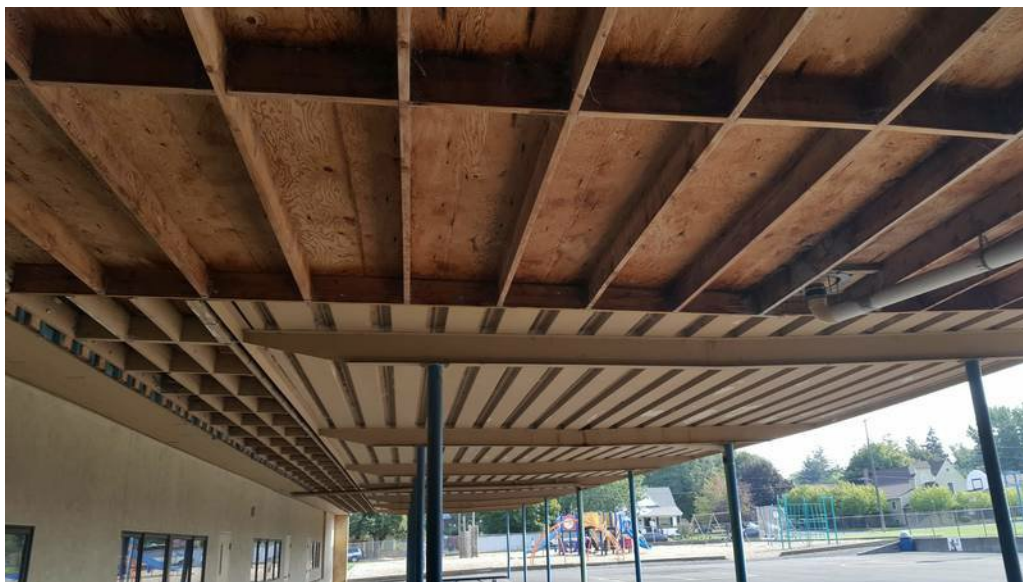
Figure 1-6. Exterior canopy showing signs of deterioration from moisture exposure.

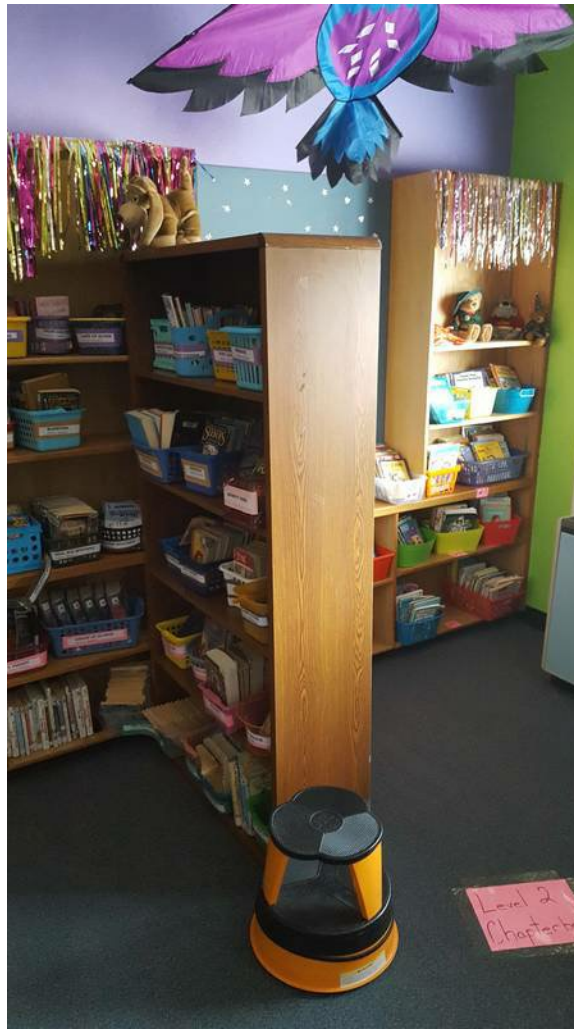
Figure 1-7. Elementary school library with tall, free-standing shelves.

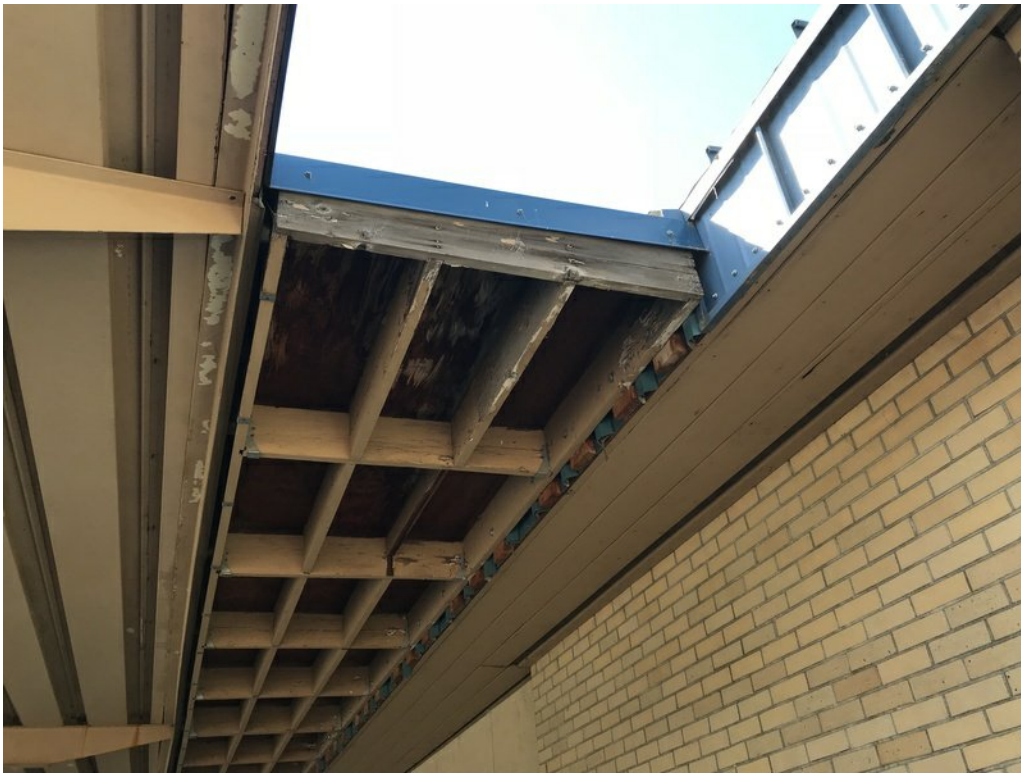
Figure 1-10. Exterior canopy connection to the building. The canopy shows signs of deterioration.
